**MEMBERS OF ODIHAM PARISH COUNCIL'S AMENITIES AREAS COMMITTEE  
ARE SUMMONED TO ATTEND THE AMENITIES AREAS COMMITTEE MEETING AT  
THE BRIDEWELL, THE BURY, ODIHAM, RG29 1NB  
TUESDAY 20<sup>th</sup> AUGUST 2024 at 8.30pm (or following conclusion of full Council)**

- AA27/24**      **Structural surveys (pages 21-35)**  
To review and note structural surveys for Chapel Cottage, North Chapel, South Chapel and the Parish Room and agree actions.

Odiham Parish Council (OPC) have asked SFK Consulting to review the properties below with a view to understanding their current structural condition and any immediate or ongoing maintenance that is likely to be required.

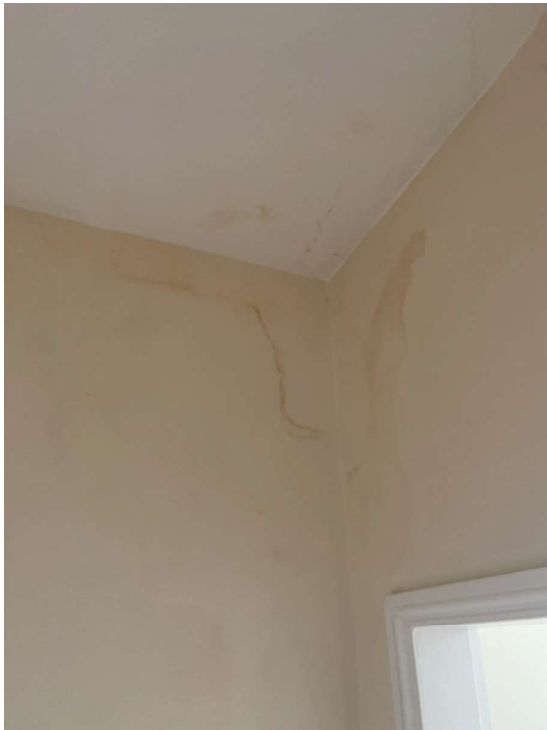
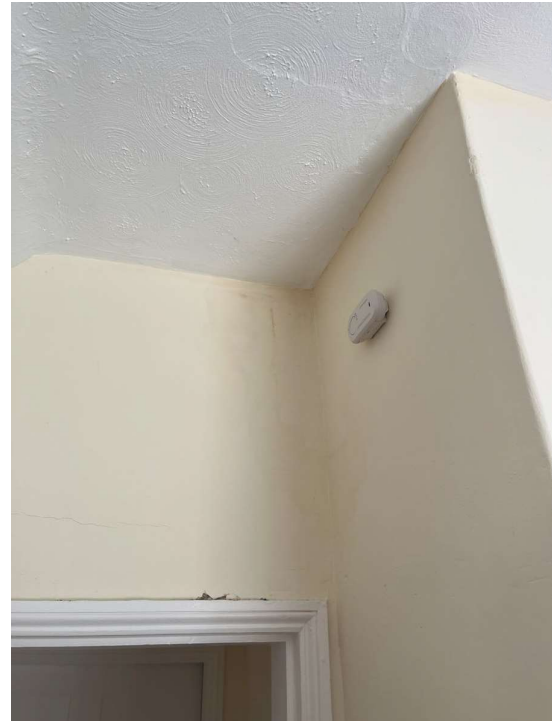
Water damage around chimney breast in main bedroom

Whilst carrying out the survey it was noted that there was damp around the internal chimney breast on the first floor (see photos below) of the northern most stack. This is likely to be evidence of water ingress via the chimney stack above. OPC's Amenity officer advised that the brickwork on the lower section of the stack had recently been repointed, although the exact date wasn't known.

We would advise that the chimney breast is redecorated internally and then monitored for any signs of further water ingress. If moisture does re-appear the following should be checked.

- The pointing on the upper sections of the chimney stack.
- Correct capping to the pots (dependant on whether the chimney is in use and the type of fire).
- The lead flashing around the base of the stack (these may well have been replaced when the lower section of the stack was repointed).

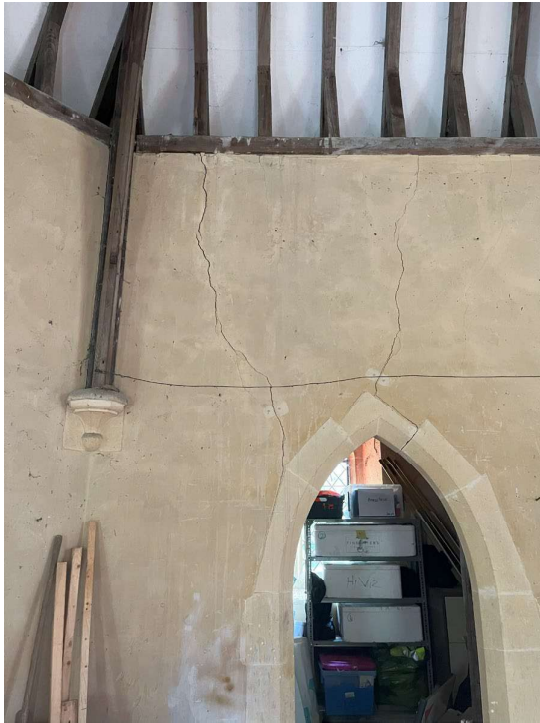
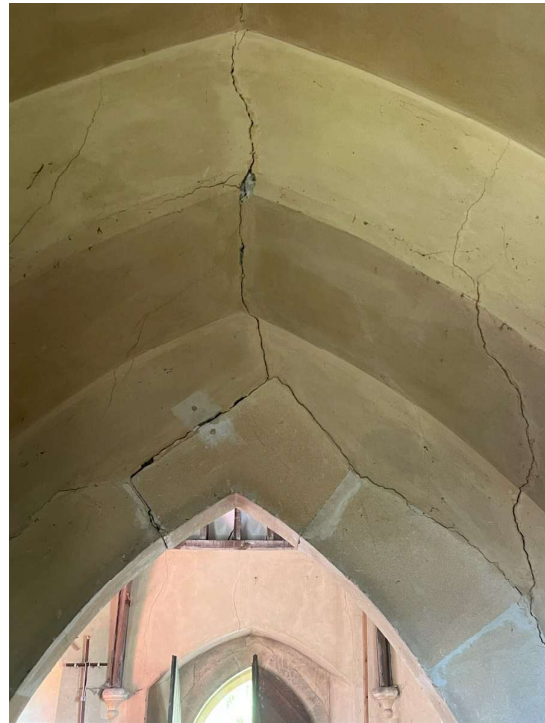
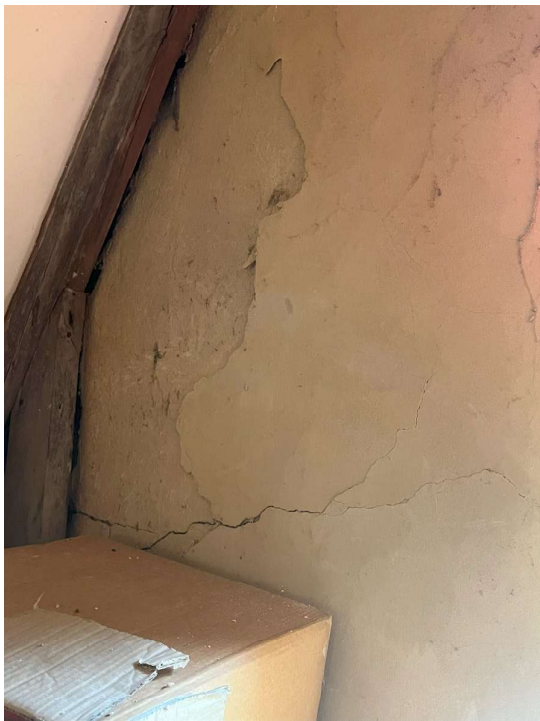
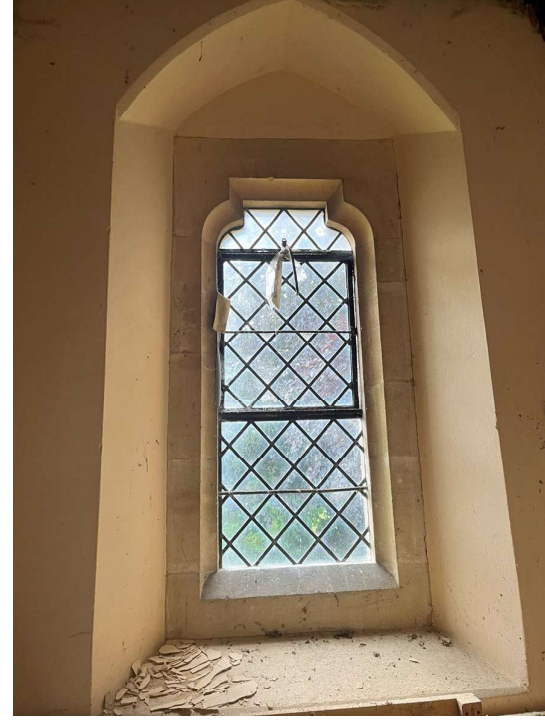
The plaster on the walls of both Chapels has blown in several places. Given that the buildings are unheated and poorly insulated spaces the internal environment will be subject to quite a wide temperature and humidity range, and it is not surprising that the plaster finish has suffered over time. We do not consider this a structural issue, but the council may wish to repair these areas for aesthetic reasons.

The following is a selection of images showing some of the internal cracking and blown plaster:

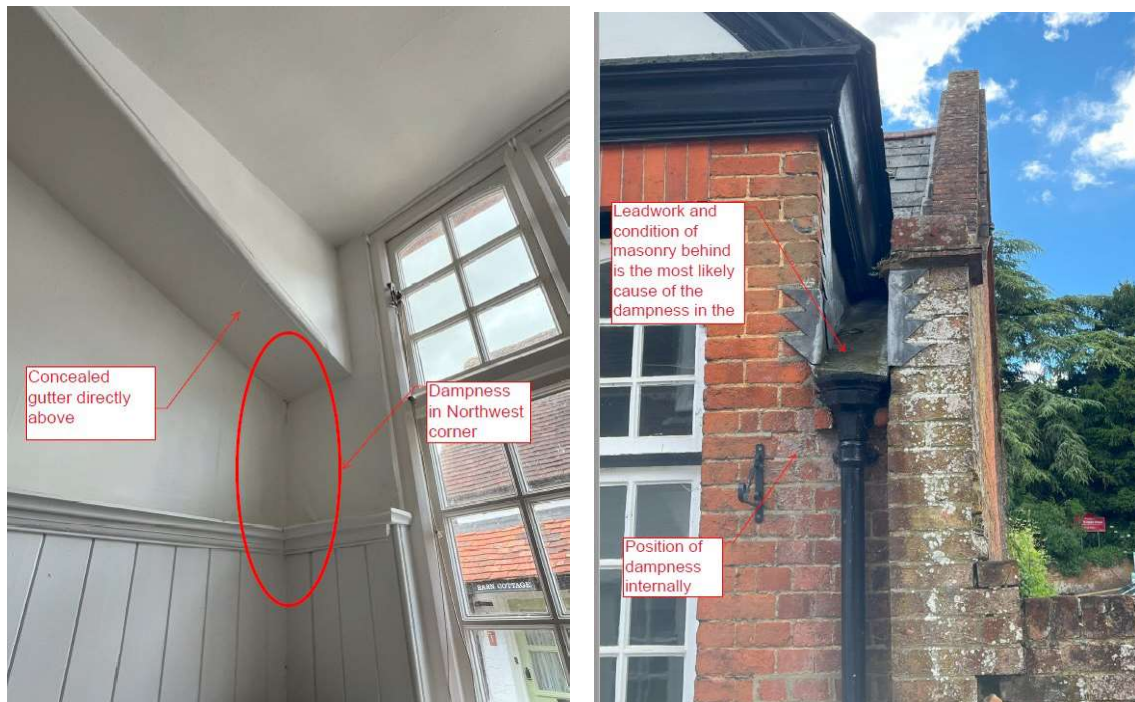
A small area of dampness was noted in the Northwest corner of the room (see photo). The corresponding external photo shows the leadwork around the concealed gutter, as this immediately adjacent to the section of damp wall internally it is most likely that moisture is finding its way through the leadwork and/or poor pointing behind. A roofing contractor should be appointed to inspect and remedy the leadwork.

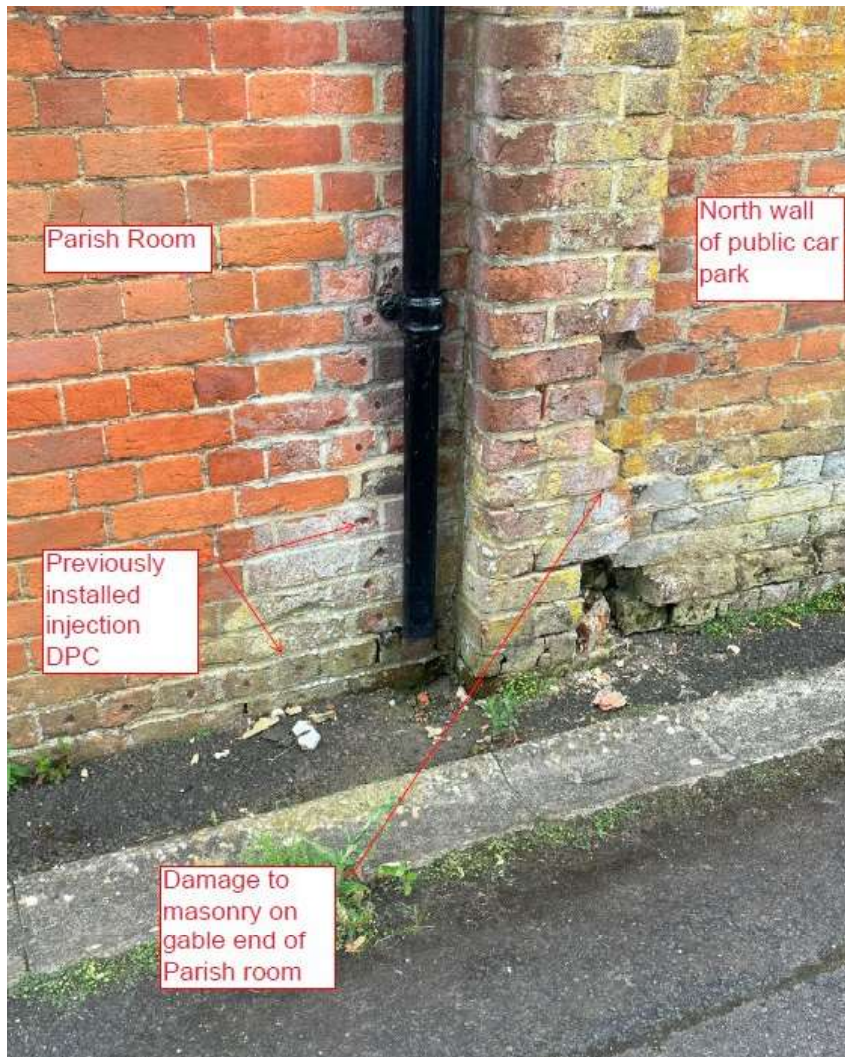
There is some damage, and loss of bricks, externally, to the gable wall at the Northwest corner. It would be prudent to repair this damage within say the next 12 months. The masonry of the gable wall appears to be toothed into the wall which runs along the North end of the public car park. We understand that the Council do not have responsibility for this section of wall, and as such the owner should be consulted before any work is undertaken.

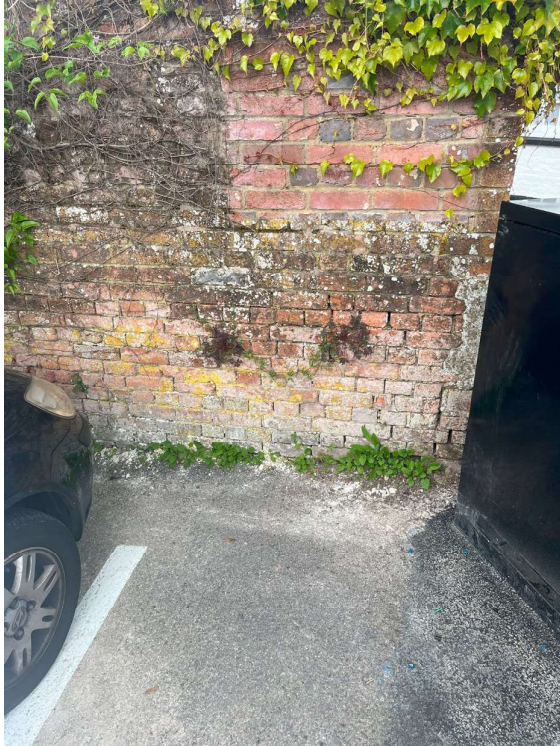
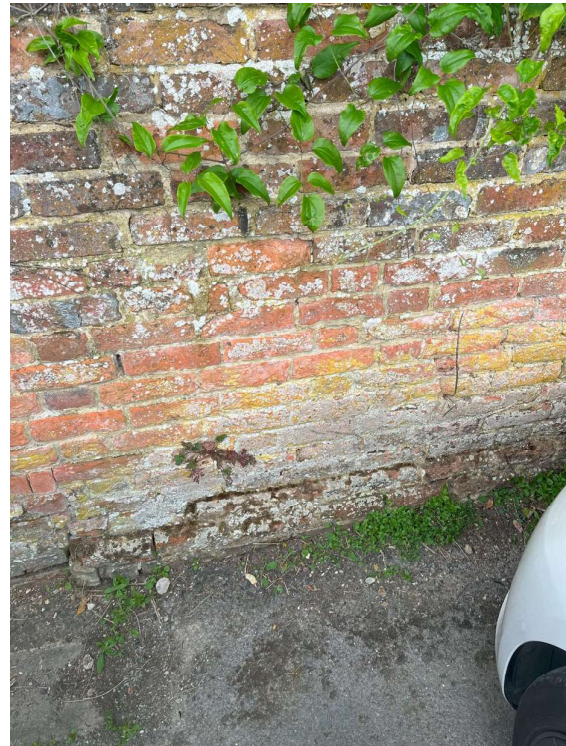
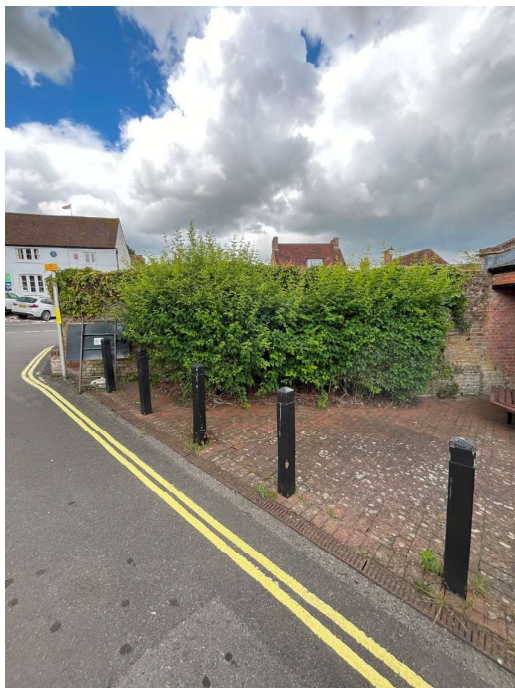
The Council are responsible for the external wall which runs along the east side of the public carpark and adjoins the Parish room. The wall is in reasonable condition and does not show signs of leaning / movement, we don't not believe there are any structural concerns at present.

The west face of the wall does show areas of grout loss and algal growth. Would advise that this face of the wall is clean and re-pointed within say they next 24 months.

We would note that the east face of the wall is covered almost entirely with vegetation. From a structural perspective it would be preferable to remove this vegetation, however we appreciate that council may prefer its visual impact. If the vegetation remains, then it should be noted that damage to the masonry and mortar courses could occur more rapidly than if it were removed.

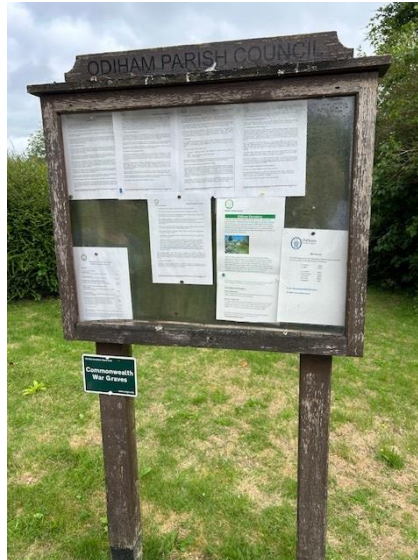
2. On verge next to entrance into open Section of cemetery (very old and leaks).
