BUSINESS PLAN FOR THE OWNERSHIP AND MANAGEMENT OF

The Bridewell, The Bury, Odiham, Hampshire, RG29 1NB

CONDITION SURVEY

Condition Review

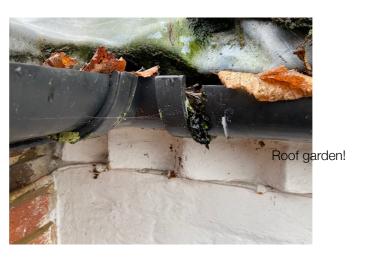
Cracked cast iron downpipe, and gutters loose in joints causing water to leak over the wall below,

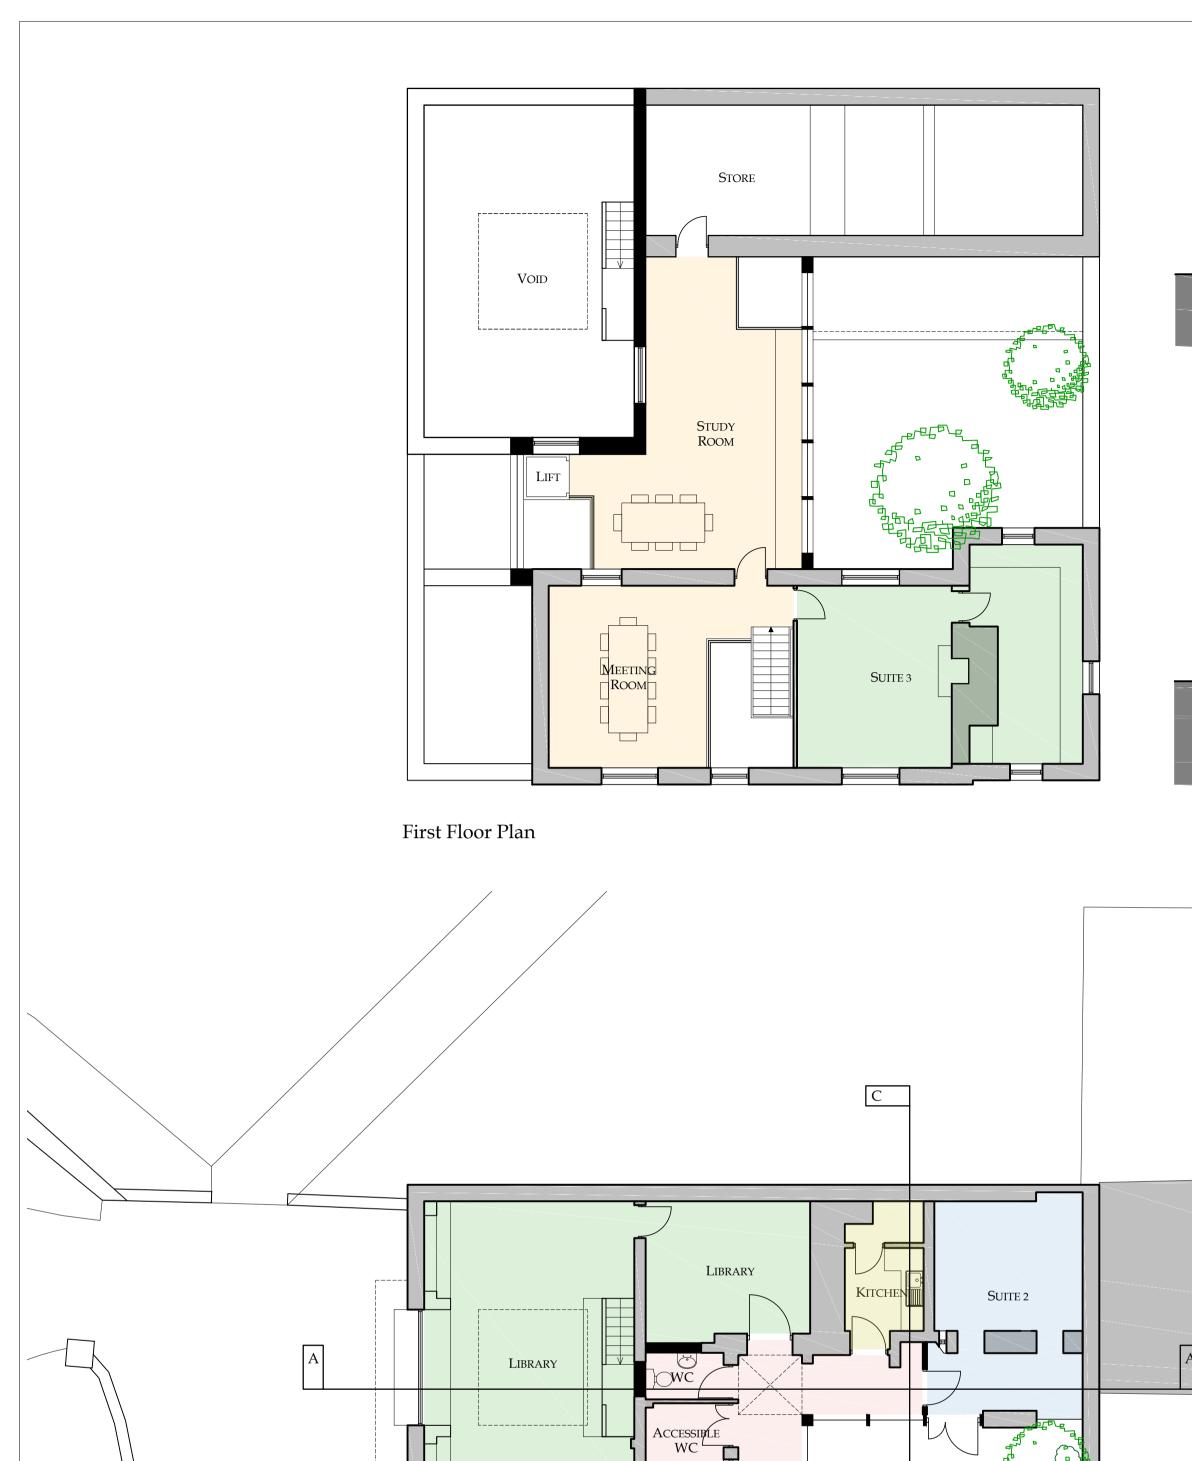
Ground Floor Plan

RECEPTION

KITCHEN

GARDEN -

0781371659 leocornall@hotmail.co	93 7	eo Cornall Architect
Project Title	Odiham Bridewell		
Project Address	The Bury, Odiham, Hampsh	ire	
Client Odiham Parish Council			
Drawing Title	Proposed Plans		
Scale	1:100 @ A1	Date	Sep. 2021
LC/006/BRI	006-001		В
Job Ref	Drawing No.		Revision
